Service Bulletin

19-011

January 30, 2019 Version 1

Safety Recall: 2016-18 MDX and 2015-19 TLX V6 Fuel Pump

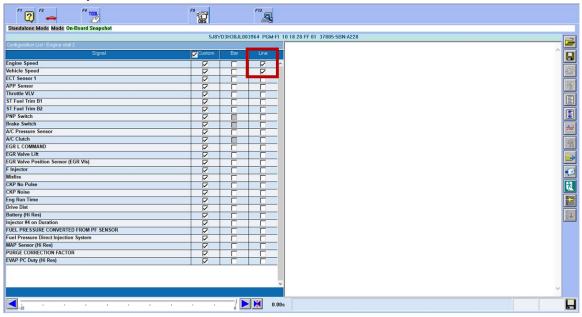
From the list of parameters, select the following:

- Engine Speed
- Vehicle Speed

5. Select the Line Graph icon. If **Engine Speed** is 0 RPM while **Vehicle Speed** is greater than 0 MPH, the engine stalled and you must do REPAIR PROCEDURE B - PGM-FI UPDATE AND FUEL PUMP REPLACEMENT.
